# WOOD DESTROYING PESTS AND ORGANISMS INSPECTION REPORT

Building No. 540A	Street 9TH AVE	City MENLO PARK	Zip 94025	Date of Inspection 6/11/09	Number of Pages 6
----------------------	-------------------	--------------------	--------------	-------------------------------	----------------------

Report # : 20061  
 Registration # : FR 4138  
 Escrow # :  
 CORRECTED REPORT

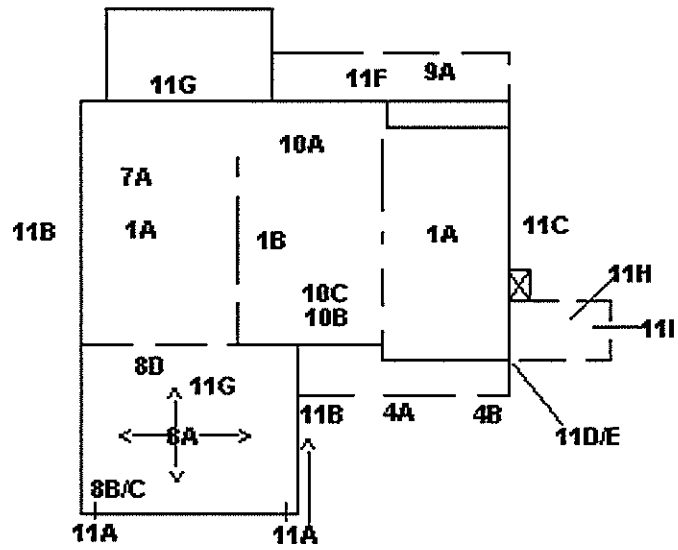
Diagram Not To Scale

01A - FINDING-INACCESSIBLE AREAS NOTED AT SUB AREA DUE TO HEATING DUCT BLOCKING ENTRY AS INDICATED BY 1A ON THE DIAGRAM.

01B - FINDING-SURFACE FUNGUS NOTED AT SUB FRAME AS INDICATED BY 1B ON THE DIAGRAM.

04A - FINDING-EXCESSIVE MOISTURE NOTED AT CRACK IN POST PAD AS INDICATED BY 4A ON THE DIAGRAM.

04B - FINDING-INACCESSIBLE AREAS NOTED AT SUPPORT POST DUE TO FOLIAGE AS INDICATED BY 4B ON THE DIAGRAM.

07A - FINDING-INACCESSIBLE AREAS NOTED AT ATTIC DUE TO BLOWN IN INSULATION AS INDICATED BY 7A ON THE DIAGRAM.

08A - FINDING-INACCESSIBLE AREAS NOTED AT GARAGE DUE TO STORAGE AS INDICATED BY 8A ON THE DIAGRAM.  
RECOMMENDATION: HI TECH TERMITE CONTROL OF THE BAY AREA RECOMMENDS FURTHER INSPECTION.  
INFORMATIONAL ITEM

08B - FINDING-EVIDENCE OF SUBTERRANEAN TERMITES NOTED AT GARAGE WALL FRAME AS INDICATED BY 8B ON THE DIAGRAM.  
RECOMMENDATION: DRILL THROUGH SLAB AND PRESSURE TREAT WITH STATE REGISTERED CHEMICAL PREMISE 75 (IMIDACLOPRID) FOR THE CONTROL OF SUBTERRANEAN TERMITES. REMOVE ALL ACCESSIBLE TUBING/SEAL HOLES. HI TECH TERMITE CONTROL OF THE BAY AREA WILL NOT BE RESPONSIBLE FOR ANY POSSIBLE DAMAGE TO HIDDEN PIPES, CONDUITS, OR DUCTS IN THE COURSE OF WORK. AREA MUST BE VACATED AT TIME OF APPLICATION. HI TECH TERMITE CONTROL OF THE BAY AREA WILL PATCH HOLES (PAINTING NOT INCLUDED). SECTION 1

08C - FINDING-SUBTERRANEAN TERMITE DAMAGE NOTED AT GARAGE WALL FRAME AS INDICATED BY 8C ON THE DIAGRAM.  
RECOMMENDATION: REMOVE AND REPLACE ACCESSIBLE SUBTERRANEAN TERMITE DAMAGED WOOD AS NECESSARY. PRIME AREA FOR PAINTING. IF DAMAGE EXTENDS INTO INACCESSIBLE AREA(S), HI TECH TERMITE CONTROL OF THE BAY AREA WILL SUBMIT A SUPPLEMENTAL REPORT AND BID IF NECESSARY.  
SECTION 1

08D - FINDING-MOISTURE STAIN NOTED AT GARAGE WALL AS INDICATED BY 8D ON THE DIAGRAM.  
RECOMMENDATION: OWNER TO CONTACT A LICENSED CONTRACTOR TO MAKE NECESSARY REPAIRS.  
SECTION 2

09A - FINDING-INACCESSIBLE AREAS NOTED AT DECK (NO CLEARANCE) AS INDICATED BY 9A ON THE DIAGRAM.  
RECOMMENDATION: HI TECH TERMITE CONTROL OF THE BAY AREA RECOMMENDS FURTHER INSPECTION.  
INFORMATIONAL ITEM

11A - FINDING-INACCESSIBLE AREAS NOTED AT BASE WALL EXTERIOR DUE TO FOLIAGE AS INDICATED BY 11A ON THE DIAGRAM.  
RECOMMENDATION: HI TECH TERMITE CONTROL OF THE BAY AREA RECOMMENDS FURTHER INSPECTION.  
INFORMATIONAL ITEM

11B - FINDING-MOISTURE DAMAGE NOTED AT WALL AS INDICATED BY 11B ON THE DIAGRAM.  
RECOMMENDATION: OWNER TO CONTACT A LICENSED CONTRACTOR TO MAKE NECESSARY REPAIRS.  
SECTION 2

11C - FINDING-EXCESSIVE MOISTURE NOTED AT WALL (PEELING PAINT) AS INDICATED BY 11C ON THE DIAGRAM.  
RECOMMENDATION: OWNER TO CONTACT A LICENSED CONTRACTOR TO MAKE NECESSARY REPAIRS.  
SECTION 2

11D - FINDING-EVIDENCE OF DRYWOOD TERMITE INFESTATION WHICH APPEARS TO BE LEADING INTO WALL VOID(S) NOTED AT SIDING TRIM AS INDICATED BY 11D ON THE DIAGRAM.  
RECOMMENDATION-PRIMARY: VACATE PREMISES AND SEAL STRUCTURE. FUMIGATE WITH A LETHAL GAS (SULFURYL

11E - FINDING-DRYWOOD TERMITE DAMAGE NOTED AT SIDING TRIM AS INDICATED BY 11E ON THE DIAGRAM.

11F - FINDING-EXCESSIVE MOISTURE NOTED AT WATER HEATER CLOSET DOOR AS INDICATED BY 11F ON THE DIAGRAM.

11G - FINDING-INACCESSIBLE AREAS NOTED AT 2ND FLOOR EAVES AS INDICATED BY 11G ON THE DIAGRAM.

11H - FINDING-INACCESSIBLE AREAS NOTED AT SIDE SHED DUE TO STORAGE AS INDICATED BY 11H ON THE DIAGRAM.

11I - FINDING-FUNGUS AND DRY ROT NOTED AT SIDE SHED AS INDICATED BY 11I ON THE DIAGRAM.

RECOMMENDATION: HI TECH TERMITE CONTROL OF THE BAY AREA RECOMMENDS FURTHER INSPECTION. INFORMATIONAL ITEM

RECOMMENDATION: SCRAPE SURFACE FUNGUS WITH STEEL WOOL BRUSH AND TREAT SURFACE FUNGUS DAMAGED WOOD WITH STATE REGISTERED FUNGICIDE TIM-BOR FOR THE CONTROL OF SURFACE FUNGUS. PRIME AREA FOR PAINTING. IF DAMAGE EXTENDS INTO INACCESSIBLE AREA(S) HI TECH TERMITE CONTROL OF THE BAY AREA WITH SUBMIT A SUPPLEMENTAL REPORT AND BID IF NECESSARY.  
SECTION 1

RECOMMENDATION: OWNER TO CONTACT A LICENSED CONTRACTOR TO MAKE NECESSARY REPAIRS.  
SECTION 2

FLUORIDE). REMOVE THE SEALS AND AIR OUT BUILDING. MAKE READY FOR OCCUPANCY. COVER AND/OR REMOVE EVIDENCE. AREA MUST BE VACATED AT TIME OF APPLICATION.

SECONDARY/SUB-STANDARD: TREAT THE ENTIRE ACCESSIBLE INFESTED AREA WITH TERMIDOR (FIPRONIL) BY INJECTION INTO THE TERMITE COLONY AND/OR TIM-BOR (DISODIUM OCTOBORATE) BY APPLYING AS A WET SPRAY TO THE TERMITE INFESTED WOOD. DRILL A 1/2" HOLE LEADING INTO WALL VOID(S). INSERT A FIBER OPTIC SCOPE TO DETERMINE IF THE INFESTATION LEADS INTO WALL VOID FRAMING. TREAT THE WALL VOID FRAMING INFESTATION WITH MICROWAVES AND/OR BORATE FOAM INJECTION. COVER AND/OR REMOVE EVIDENCE. STRUCTURE MUST BE VACATED AT TIME OF APPLICATION. HI TECH TERMITE CONTROL OF THE BAY AREA WILL PATCH HOLES (PAINTING NOT INCLUDED).

RECOMMENDATION: REMOVE AND REPLACE ACCESSIBLE DRYWOOD TERMITE DAMAGED WOOD AS NECESSARY. PRIME AREA FOR PAINTING. IF DAMAGE EXTENDS INTO INACCESSIBLE AREA(S) HI TECH TERMITE CONTROL OF THE BAY AREA WILL SUBMIT A SUPPLEMENTAL REPORT AND BID IF NECESSARY.

RECOMMENDATION: OWNER TO CONTACT A LICENSED CONTRACTOR TO MAKE NECESSARY REPAIRS.

RECOMMENDATION: DISASSEMBLE & REMOVE SIDE SHED FROM THE PREMISES.
