**Peter M. Buenrostro**  
 Residential and Commercial Property Inspections  
 A Member of the Real Estate Inspection Group, Inc.  
 www.inspectiongroup.com

<b>Inspection Date:</b> May 27, 2009		<b>Inspection Time:</b> 9:00 a.m. <b>Report Number:</b> 1052709PB	
<b>Inspection Address:</b> 836 Live Oak Avenue		<b>Cross Street:</b> Evelyn Street	
<b>Inspection City:</b> Menlo Park		<b>State:</b> CA <b>Zip:</b> 94025 <b>Approx. Sq Ft:</b> 1840	
<b>Client's First Name:</b> Carol	<b>Last:</b> Johnston	<b>Listing Inspection:</b> <input checked="" type="checkbox"/> (Fee due within 90 days)	
<b>Agent's First Name:</b> Katrina	<b>Last:</b> Edward	<b>Office:</b> Triumph Property Svcs., Palo Alto	
<b>Phone:</b> (650) 813-0141	<b>Ext:</b>	<b>Fax:</b>	<b>E-mail:</b> katrina@triumphps.com
<b>Amount:</b> 485.00	<b>Add:</b> -40.00	<b>For:</b> \$40 overpayment refunded	<b>Billing Fee:</b> 0.00 <b>Total:</b> \$445.00

836 Live Oak Avenue

**1-800-900-1239****www.inspectiongroup.com****PROPERTY INSPECTION****Inspection Address:** 836 Live Oak Avenue**Report Number:** 1052709PB**Inspection City:** Menlo Park**Inspection Date:** May 27, 2009**Client's First Name:** Carol**Last:** Johnston**Listing Inspe

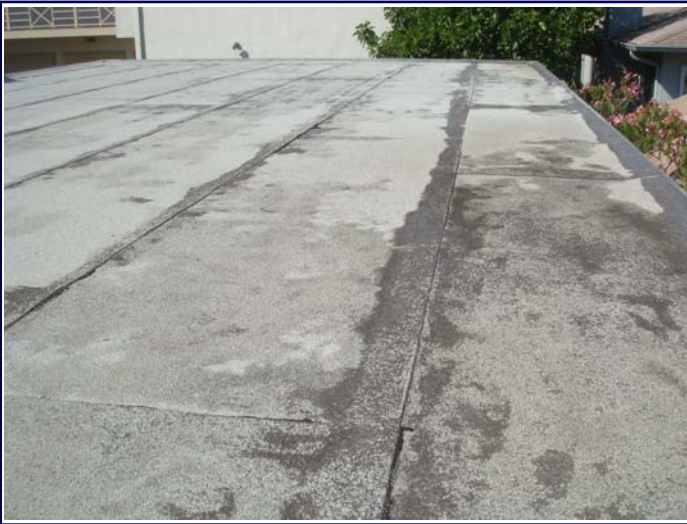
**Photo 1**

The low-slope roof over the carport was in weathered condition. See "Exterior I Action Item 1" on page 5.

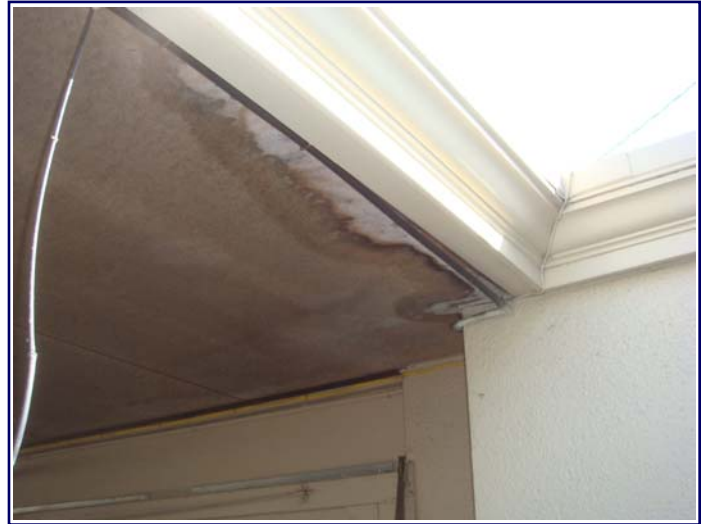
**Photo 2**

Water stains on the gypsum board under the carport roof. See "Exterior I Action Item 1" on page 5.

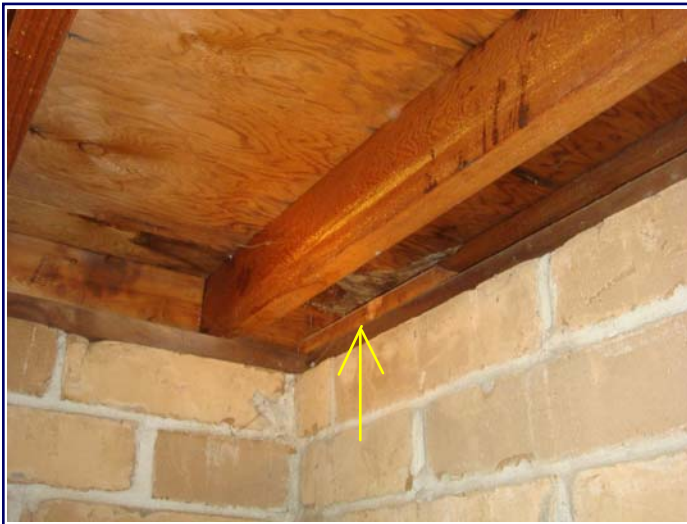
**Photo 3**

Damaged plywood roof sheathing in the right rear corner of the carport storage room. See "Exterior I Action Item 1" on page 5.

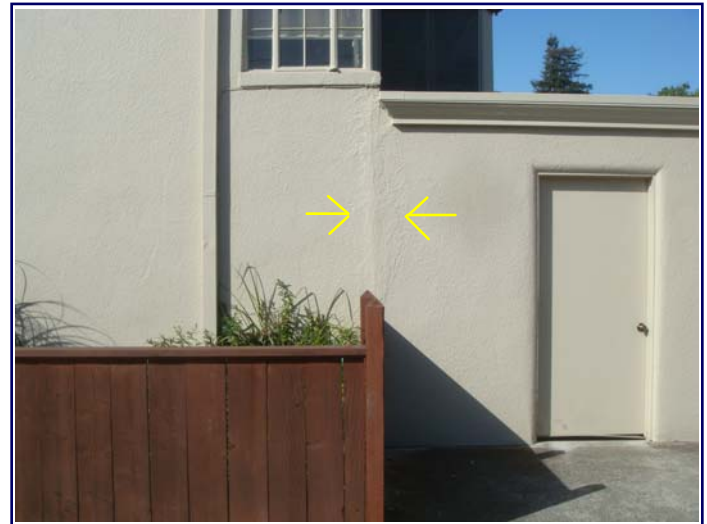
**Photo 4**

Cracks in the stucco at the connection between the house and the wall to the carport were previously patched. See "Exterior I Action Item 4", page 24.

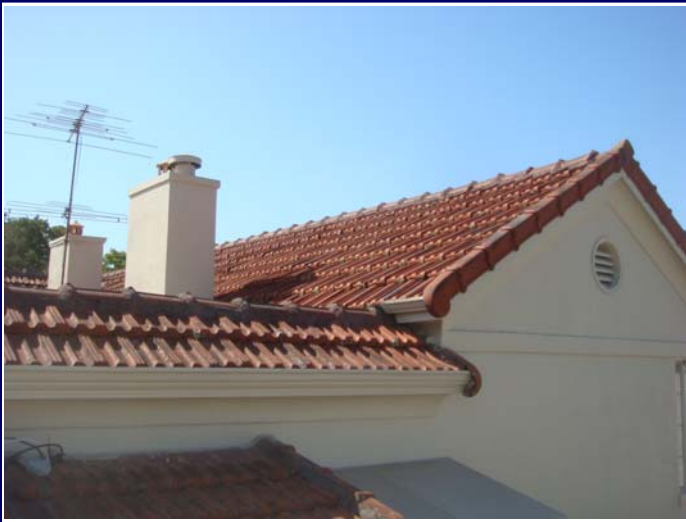
**Photo 5**

The wood framed flue chases for the gas appliances were not accessible. See "Exterior I Action Item 5" on page 24.

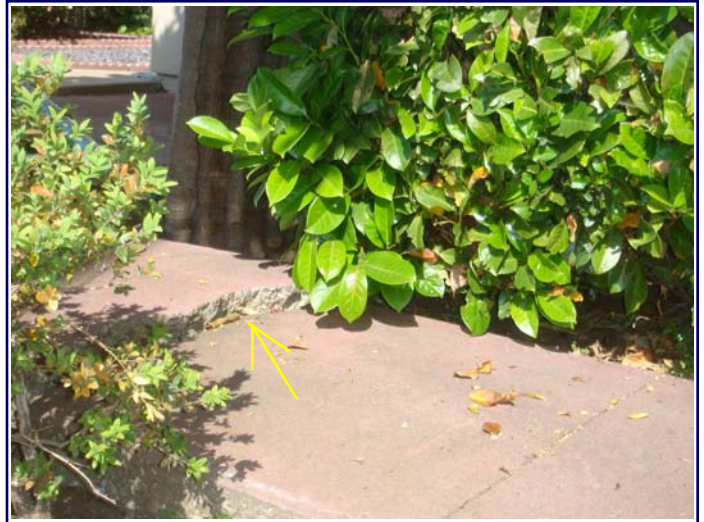
**Photo 6**

1) Walkways: A section of the front walkway was displaced by tree roots and is a possible trip hazard (see Photo 6). I recommend forming a concrete ramp to smooth the transition, or having the walkway replaced. The tree roots may continue to grow and cause damage. It would be prudent to consult an appropriate licensed and certified arborist for advisement on root pruning or other options to avoid future damage.

A trip hazard at the front walkway. See "Exterior II Action Item 1" on page 6.

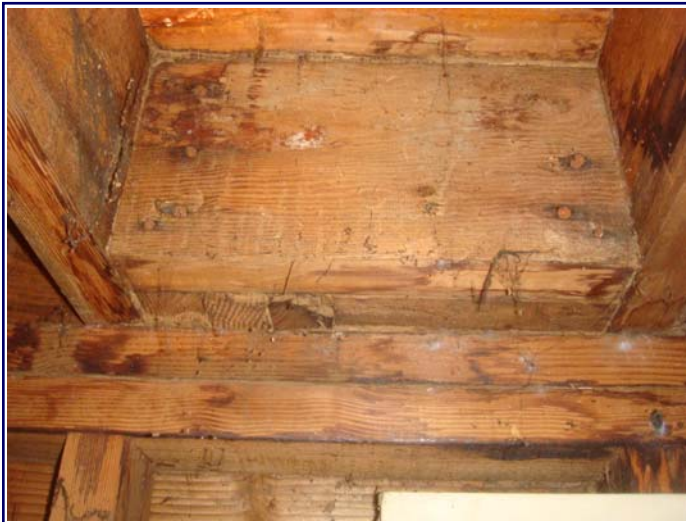
**Photo 7**

2) Porches: (a) Damaged wood framing was seen under the front porch from inside the basement (Photo 7). The bottom of the rail post near the bottom step at the rear porch was damaged. I recommend consulting an appropriate licensed pest control operator for further advisement and having corrective measures performed as needed. (b) The lower wood rail at the rear porch is cracked and should be replaced for safety. (c) The gaps between the vertical rails on the front porch steps and rear porch steps exceed the current four-inch (4") maximum. Use appropriate caution. The steps and railing predate the current requirements. I recommend upgrading the railings for compliance with the current standards for greater safety. (d) The rear porch slopes downward away from the kitchen door (Photo 8). If a level floor is desired consult an appropriate licensed contractor for re-framing the porch.

Damaged wood framing under the front porch seen from the basement. See "Exterior II Action Item 2(a)" on page 6.

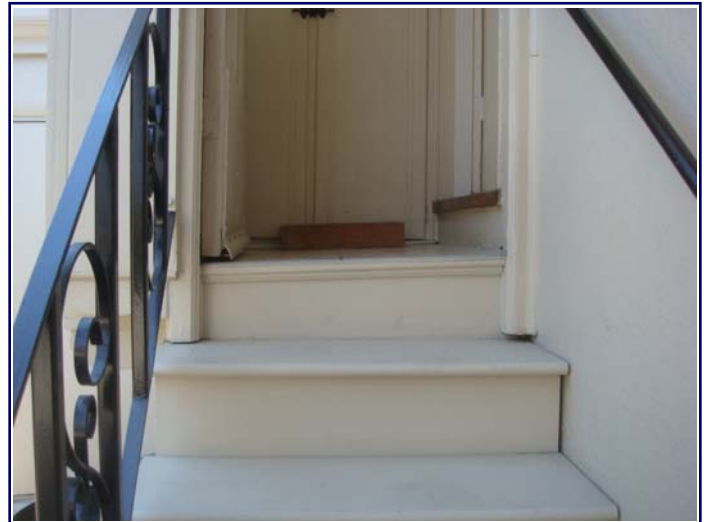
**Photo 8**

The rear porch slopes downward away from the kitchen door. See "Exterior II Action Item 2(d)" on page 6.

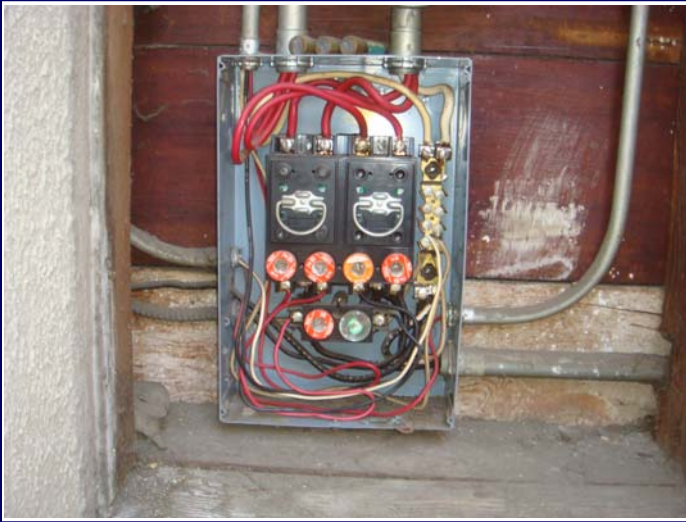
**Photo 9**

1) Main Panel: (a) The two fuse blocks in the 100 amp service were fitted with 60 amp fuses (Photo 9). The most common 100 amp fused services use a pair of 60 amp fuses in the left fuse block (the "Main & Lighting" fuse block) and a pair of 40-amp fuses in the right fuse block (the "Range" fuse block). I recommend installing 40-amp rated fuses in the right fuse block to ensure that the wiring is protected. (b) A ground rod was not located for the panel. A wire with white insulation and a clamp has been disconnected from a pipe in the basement about mid-way along the right foundation wall. It may have been a ground wire, as it was common practice in older houses to ground the panels to water pipes but is now considered substandard. I recommend verifying that the panel is properly grounded and having the grounding corrected if necessary.

The two fuse blocks in the 100 amp service were fitted with 60 amp fuses. (The panel cover was removed for the photo.) See "Electrical Action Item 1" on page 7.

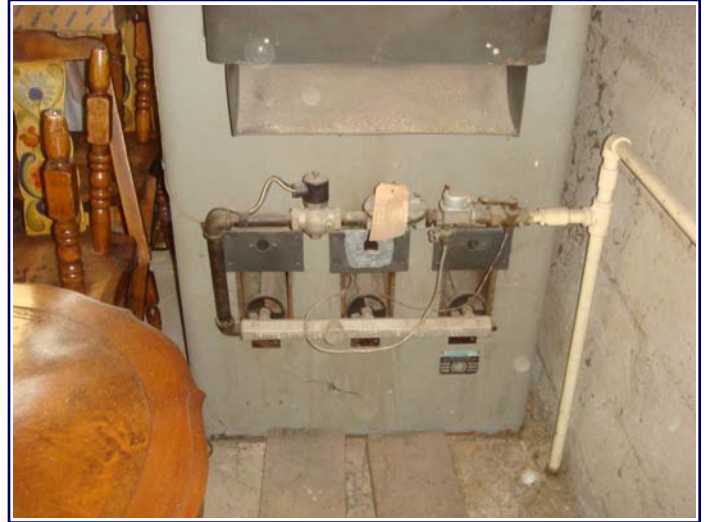
**Photo 10**

1) Furnace: The furnace is at least 40 years old and should be considered to be at or near the end of its expected service life (Photo 10). The furnace had some interior corrosion. Stored items prevented access to the fan compartment. We recommend having furnaces over 10 years old serviced and checked annually as older heat exchangers are more likely to develop cracks. A cracked heat exchanger could leak carbon monoxide. Per the ASHI Standards the inside of the heat exchanger is not within the scope of this inspection. A qualified HVAC contractor can perform a full inspection of the heat exchanger. PG&E offers a safety check at no charge upon request (1-800-PGE-5000). Additionally, if a carbon monoxide (CO) monitor were to be installed in the house it could give an early warning of problems with the heat exchanger or other sources of combustion.

The furnace is at least 40 years old. See "Heating System Action Item 1" on page 8 for comments.

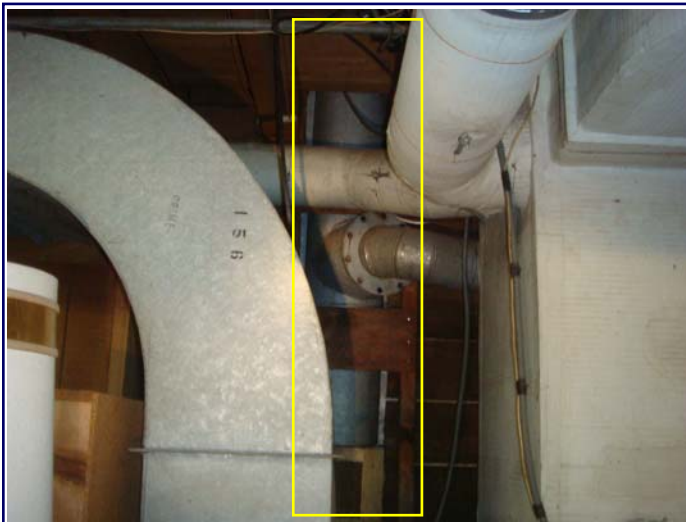
**Photo 11**

2) Furnace Flue: The main flue for the furnace and water heater is in contact with some of the wall framing (Photo 11). I recommend obtaining the recommended clearances to the wood framing for fire safety.

The main flue for the furnace and water heater has substandard clearances to the wall framing. See "Heating System Action Item 2" on page 8.

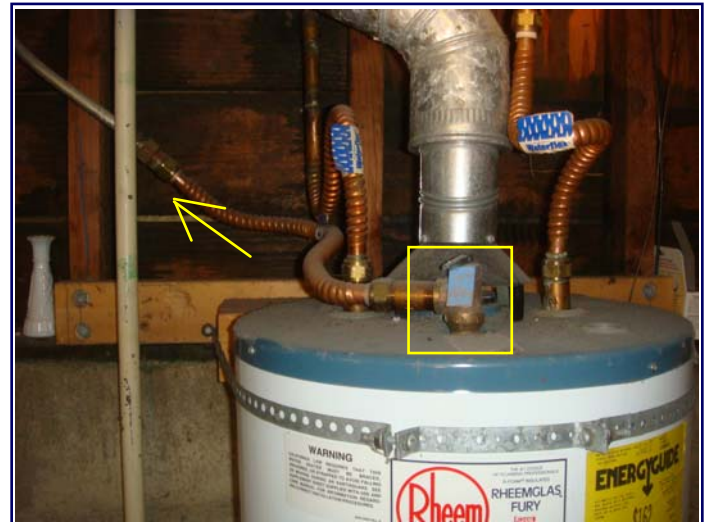
**Photo 12**

1) Water Heater: (a) The water heater had only one strap and should be re-strapped for compliance with the current local requirements. (b) The Temperature Pressure (TP) relief valve drain on the water heater sloped upwards and was connected to smaller diameter tubing before terminating outdoors (Photo 12). This is an improper installation and a possible safety hazard. Drain pipes should slope continually downward away from a TP valve to allow complete drainage of the pipe and have a minimum 3/4" inside diameter. The basement had no visible floor drain, so ending the drain pipe above the slab is not recommended. I recommend further evaluation by an appropriate licensed plumbing contractor for corrections as needed. (In some cities installing a Watts 210 device is an acceptable correction.) (c) The water heater is 15 years old and should be considered to be at or near the end of a typical expected service life. It is functional at this time. Monitor it for leaks.

The Temperature Pressure (TP) relief valve drain on the water heater has an upward slope. The water heater has one seismic strap. See "Plumbing Action Item 1" on page 9.

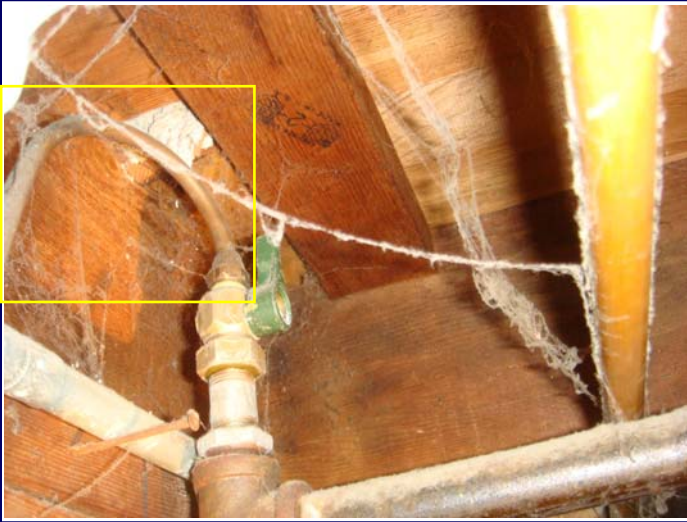
**Photo 13**

2) Clothes Dryer Connections: (a) Copper tubing supplies gas to the gas clothes dryer, as was common in older houses (Photo 13). I recommend upgrading to a new, compliant flexible gas connector for safety. (b) The clothes dryer vent discharges into a water-filled lint trap inside the basement. I recommend installing an approved dryer duct vent with a hood and damper at a convenient location on an outside wall to divert heat and moisture outside.

Copper tubing supplies natural gas to the clothes dryer. See "Plumbing Action Item 2" on page 9.

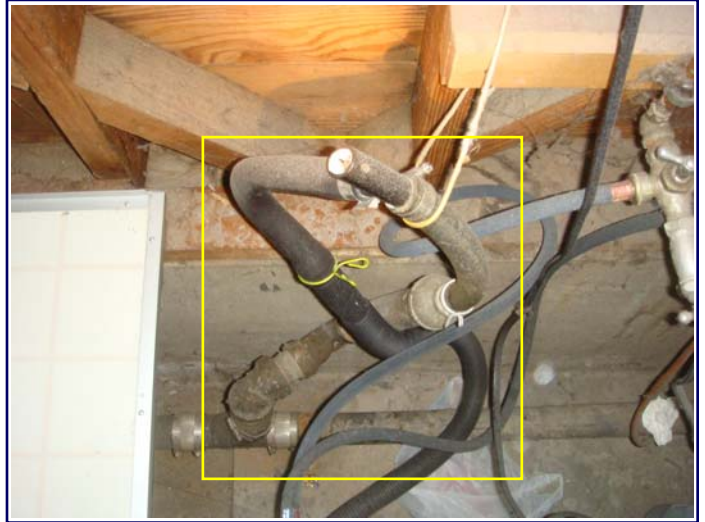
**Photo 14**

The washing machine discharge hose is connected to a substandard standpipe assembly. See "Plumbing Action Item 4" on page 24.

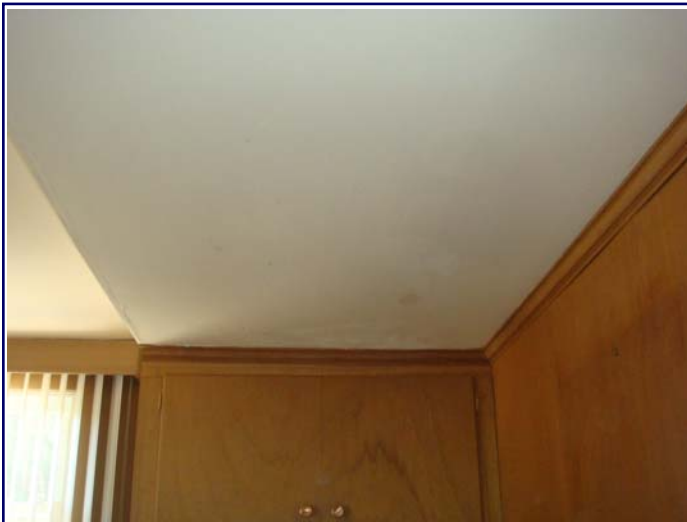
**Photo 15**

The family room ceiling below the main bathroom has been previously patched. See "Bathrooms Action Item 1(b)" on page 11.

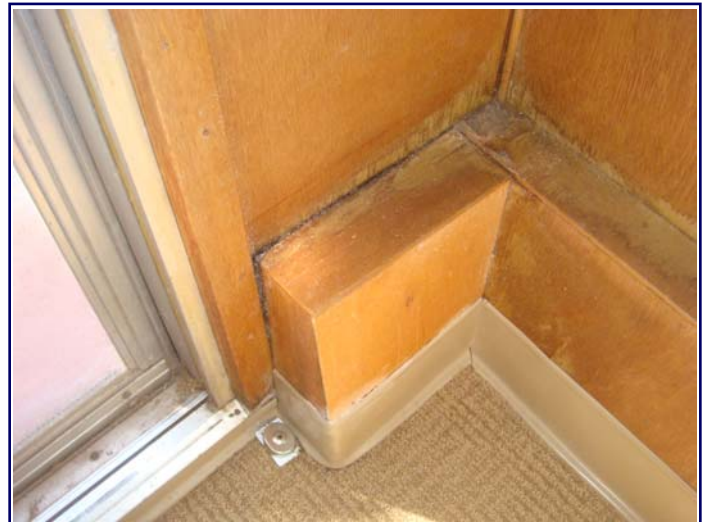
**Photo 16**

Damaged wood paneling near the left front corner of the family room. See "Interior Action Item 4" on page 25.

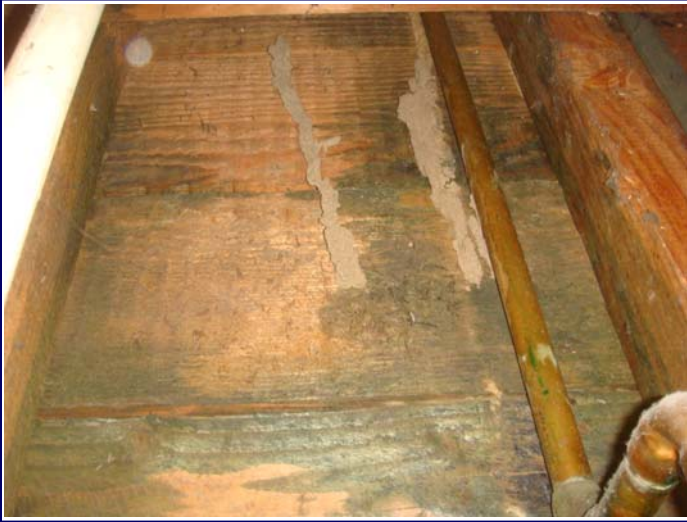
**Photo 17**

Tubular structures on the basement wall shared with the family room. See "Interior Action Item 4" on page 25.

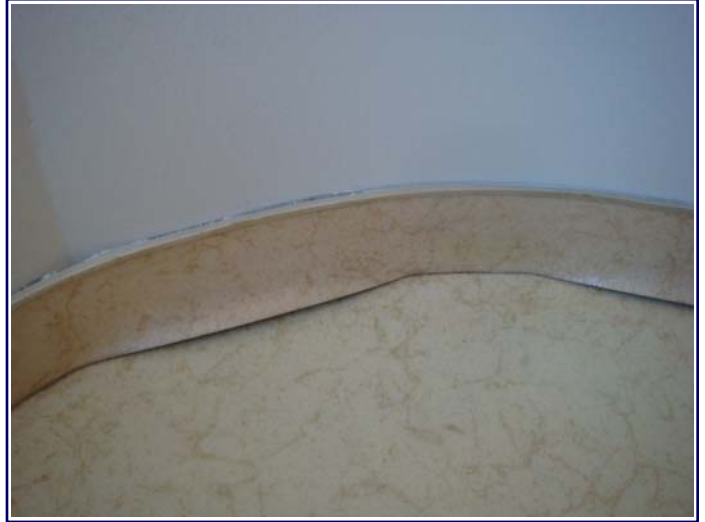
**Photo 18**

The linoleum installed at the base of the wall inside the room adjacent to the powder room was loose. See "Interior Action Item 5" on page 25.

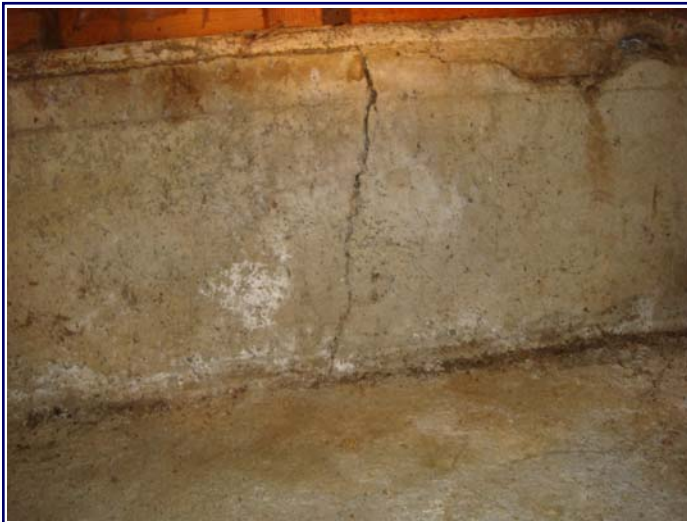
**Photo 19**

A vertical crack about 1/4" wide on the front foundation wall under the front porch. See "Foundation and Framing Action Item 1", page 25.

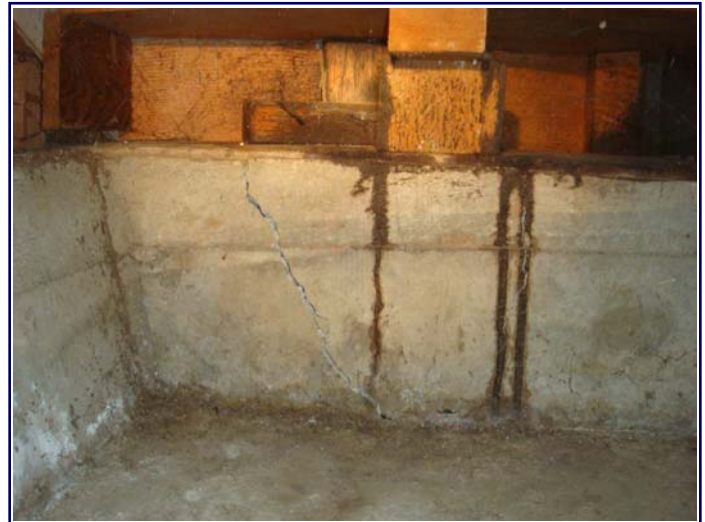
**Photo 20**

An angled crack on an interior foundation wall under the interior steps between the living room and the family room. See "Foundation and Framing Action Item 1" on page 25.

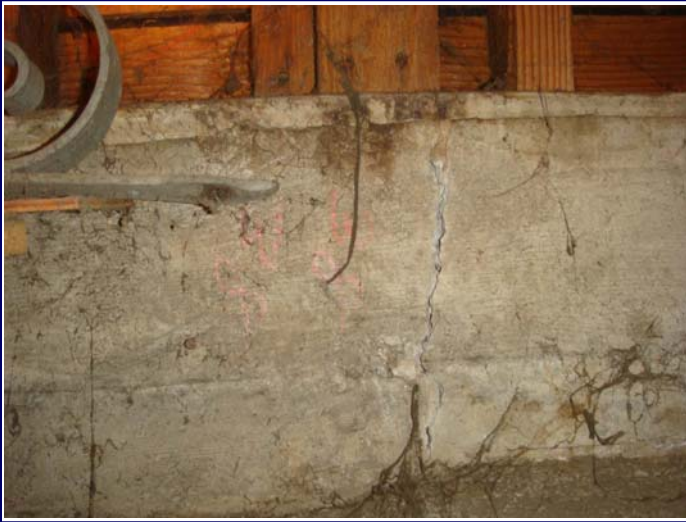
**Photo 21**

A vertical crack about 1/4" wide on the right foundation wall of the basement a few feet from the front foundation wall. See "Foundation and Framing Action Item 1" on page 25.

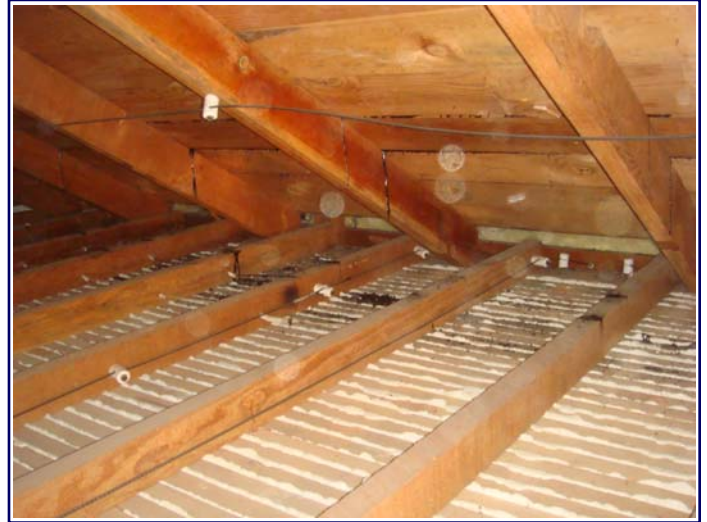
**Photo 22**

Fiberglass batt insulation can be seen in the attic near the base of the rafters next to the dining room. Most of the ceilings were not insulated. Note the knob and tube wiring. See "Foundation and Framing Action Item 4", page 25.
