WOOD DESTROYING PESTS AND ORGANISMS INSPECTION REPORT

Building No. 1035	Street NEWHALL ST.	City SAN JOSE	Zip 95128	Date of inspection 5/1/2006	Number of Pages 6
----------------------	-----------------------	------------------	--------------	--------------------------------	----------------------

Report #: 14796
 Registration #: PR 4138
 Escrow #:

GENERAL DESCRIPTION: 1 STORY WOODSIDING AND FRAME RESIDENCE FURNISHED AND OCCUPIED WITH A COMPOSITION ROOF ATTACHED GARAGE UNIMPROVED UNDER AREA AND SLEEPER.

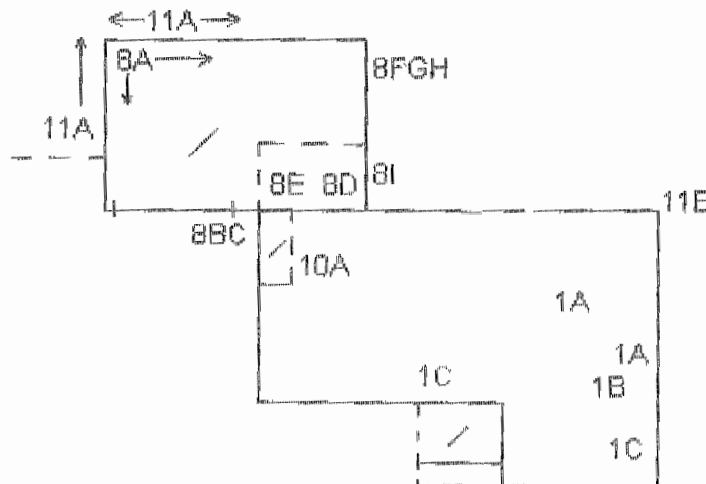
Diagram Not To Scale

01A - FINDING-CELLULOSE DEBRIS NOTED AT SUBAREA AS INDICATED BY 1A ON THE DIAGRAM.

01B - FINDING-SURFACE FUNGUS NOTED AT SUBFLOOR PLUMBING ACCESS AS INDICATED BY 1B ON THE DIAGRAM.

01C - FINDING-EXCESSIVE MOISTURE NOTED AT FOUNDATIONS AS INDICATED BY 1C ON THE DIAGRAM.

08A - FINDING-INACCESSIBLE AREAS NOTED AT GARAGE WALLS DUE TO STORAGE AS INDICATED BY 8A ON THE DIAGRAM.

08B - FINDING-EVIDENCE OF DRYWOOD TERMITE INFESTATION WHICH APPEARS TO BE LEADING INTO WALL VOID(S) NOTED AT GARAGE BOXED EAVE AS INDICATED BY 8B ON THE DIAGRAM.

08C - FINDING-DRYWOOD TERMITE DAMAGE NOTED AT GARAGE BOXED EAVE AS INDICATED BY 8C ON THE DIAGRAM.

08D - FINDING-MOISTURE STAIN NOTED AT WALL ABOVE GARAGE SIDE DOOR AS INDICATED BY 8D ON THE DIAGRAM.

08E - FINDING-INACCESSIBLE AREAS NOTED AT DECK ELEVATED PORCH DUE TO SLEEPER CONSTRUCTION AS INDICATED BY 8E ON THE DIAGRAM.

08F - FINDING-FUNGUS AND DRY ROT NOTED AT GARAGE SIDING AS INDICATED BY 8F ON THE DIAGRAM.

08G - FINDING-EVIDENCE OF SUBTERRANEAN TERMITES NOTED AT GARAGE SIDING AS INDICATED BY 8G ON THE DIAGRAM.

08H - FINDING-SUBTERRANEAN TERMITE DAMAGE NOTED AT GARAGE SIDING AS INDICATED BY 8H ON THE DIAGRAM.

08I - FINDING-FUNGUS AND DRY ROT NOTED AT GARAGE SIDE DOOR PORCH STEP AS INDICATED BY 8I ON THE DIAGRAM.

10A - FINDING-INACCESSIBLE AREAS NOTED AT DINING ROOM DUE TO DOOR WAS PAINTED SHUT AS INDICATED BY 10A ON THE DIAGRAM.

11A - FINDING-INACCESSIBLE AREAS NOTED AT PORTIONS OF EXTERIOR DUE TO ZERO PROPERTY LINE AS INDICATED BY 11A ON THE DIAGRAM.

11B - FINDING-FUNGUS AND DRY ROT NOTED AT BOXED EAVE AS INDICATED BY 11B ON THE DIAGRAM.

RECOMMENDATION: OWNER TO REMOVE CELLULOSE DEBRIS FROM PROPERTY.
 SECTION 2

RECOMMENDATION: OWNER TO CONTACT A LICENSED CONTRACTOR TO MAKE NECESSARY REPAIRS.
 SECTION 1

RECOMMENDATION: OWNER TO CONTACT A LICENSED CONTRACTOR TO MAKE NECESSARY REPAIRS.
 SECTION 2

RECOMMENDATION-HI TECH TERMITE CONTROL OF THE BAY AREA RECOMMENDS FURTHER INSPECTION.
 SECTION 2

RECOMMENDATION-PRIMARY: VACATE PREMISES AND SEAL STRUCTURE. FUMIGATE WITH A LETHAL GAS (SULFURYL FLUORIDE). REMOVE THE SEALS AND AIR OUT BUILDING. MAKE READY FOR OCCUPANCY. COVER AND/OR REMOVE EVIDENCE. AREA MUST BE VACATED AT TIME OF APPLICATION.

SECONDARY/SUB-STANDARD: TREAT THE ENTIRE ACCESSIBLE INFESTED AREA WITH TERMIDOR (FIPRONIL) BY INJECTION INTO THE TERMITE COLONY AND/OR TIM-BOR (DISODIUM OCTOBORATE) BY APPLYING AS A WET SPRAY TO THE TERMITE INFESTED WOOD. DRILL A 1/2" HOLE LEADING INTO WALL VOID(S). INSERT A FIBER OPTIC SCOPE TO DETERMINE IF THE INFESTATION LEADS INTO WALL VOID FRAMING. TREAT THE WALL VOID FRAMING INFESTATION WITH MICROWAVES AND/OR BORATE FOAM INJECTION. COVER AND/OR REMOVE EVIDENCE. STRUCTURE MUST BE VACATED AT TIME OF APPLICATION. HI TECH TERMITE CONTROL OF THE BAY AREA WILL PATCH HOLES (PAINTING NOT INCLUDED).
 SECTION 1

RECOMMENDATION: OWNER TO CONTACT A LICENSED CONTRACTOR TO MAKE NECESSARY REPAIRS.
SECTION 1

RECOMMENDATION: OWNER TO CONTACT A LICENSED CONTRACTOR TO MAKE NECESSARY REPAIRS.
SECTION 2

RECOMMENDATION-HI TECH TERMITE CONTROL OF THE BAY AREA RECOMMENDS FURTHER INSPECTION.
SECTION 2

RECOMMENDATION: DRILL THROUGH SLAB AND PRESSURE TREAT WITH STATE REGISTERED CHEMICAL PRELUDE (PERMETHRIN) FOR THE CONTROL OF SUBTERRANEAN TERMITES. REMOVE ALL ACCESSIBLE TUBING/SEAL HOLES. HI TECH TERMITE CONTROL OF THE BAY AREA WILL NOT BE RESPONSIBLE FOR ANY POSSIBLE DAMAGE TO HIDDEN PIPES, CONDUITS, OR DUCTS IN THE COURSE OF WORK. AREA MUST BE VACATED AT TIME OF APPLICATION. HI TECH TERMITE CONTROL OF THE BAY AREA WILL PATCH HOLES (PAINTING NOT INCLUDED).
SECTION 1

RECOMMENDATION-HI TECH TERMITE CONTROL OF THE BAY AREA RECOMMENDS FURTHER INSPECTION.
