Kristian Meyers
 Residential and Commercial Property Inspections
 A Member of the Real Estate Inspection Group, Inc.
 www.inspectiongroup.com

Inspection Date: April 13, 2010	Inspection Time: 9:30 AM	Report Number: 041310
Inspection Address: 19 Antioch Dr.		
Inspection City: San Mateo	State: CA	Zip: 94403 Approx. Sq Ft: 1190
Client's Name: Paula Mas	Listing Inspection: <input checked="" type="checkbox"/> (Fee due within 90 days)	
Agent's Name: Katrina Edwards	Office: Triumph Property Services	
Phone: 650-813-1413	E-mail: katrina@triumphps.com	
Amount: \$425.00	Add:	For:
	Billing Fee:	Total: \$425.00

REAL ESTATE INSPECTION GROUP, INC.

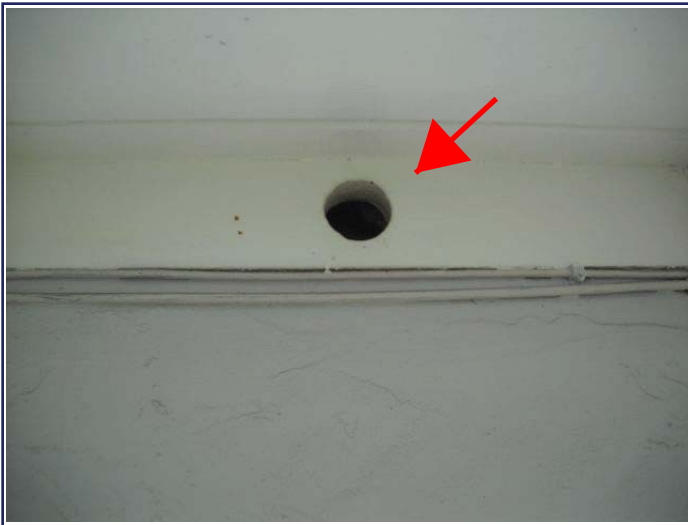
Photo 1

Missing garage vent screen at the front of the house.

3. A few of the attic and garage vent screens at the front, left side and rear of the house were damaged and should be repaired to keep out pests. Additionally, the clothes dryer exhaust damper was damaged and should be replaced.

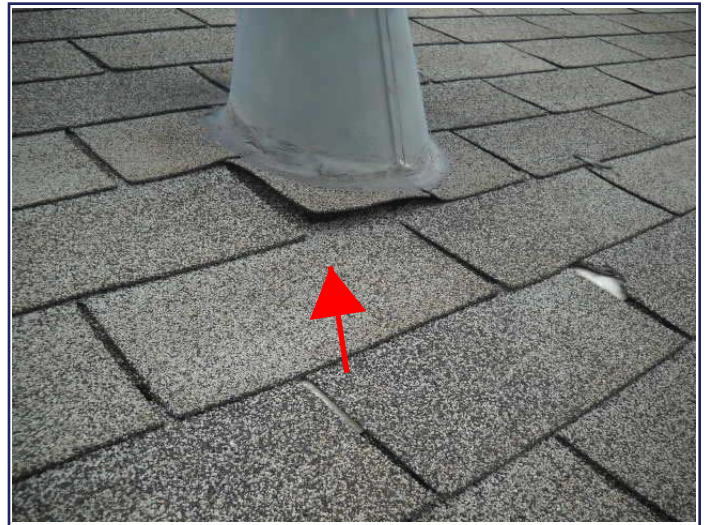
Photo 2

Lifted shingle at the front roof.

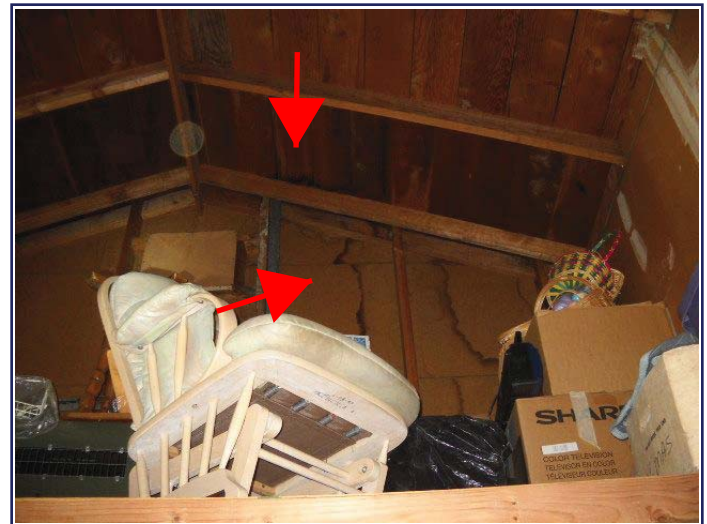
Photo 4

Stains visible at the left side of the garage.

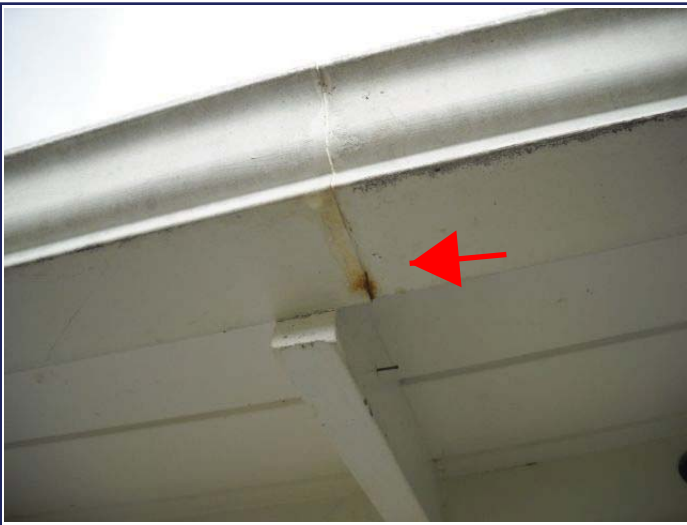
Photo 5

Leaking gutter joint.

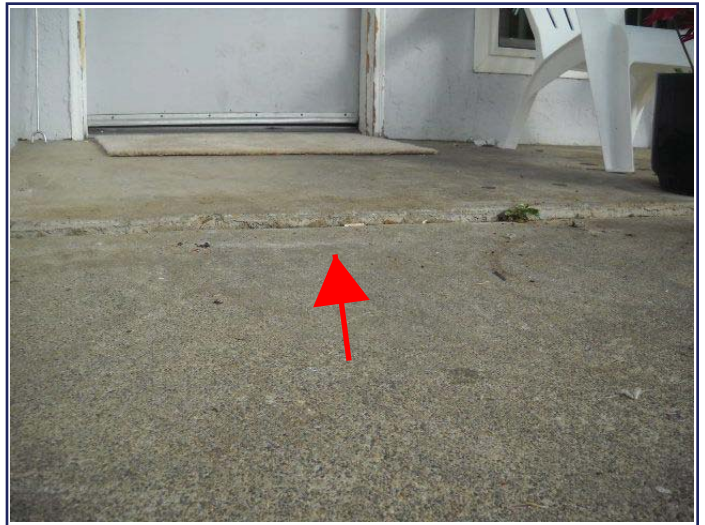
Photo 6

Trip hazard at the front of the house.

EXTERIOR II ACTION ITEMS:
 The uneven concrete surfaces between the front walkway and porch, and at the left side walkway are trip hazards. I recommend further evaluation by a qualified contractor and repairs as necessary.

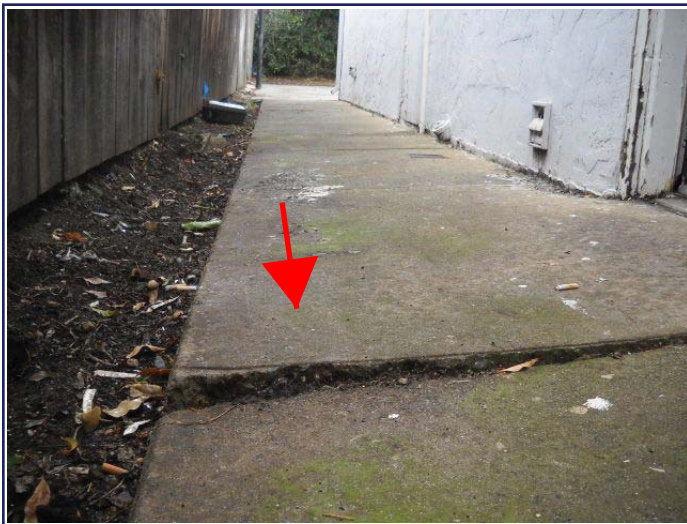
Photo 7

Trip hazard at the left side walkway.

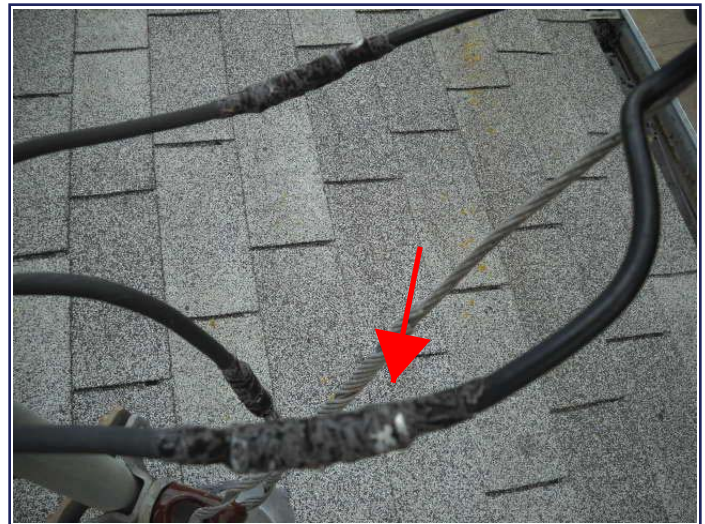
Photo 8

Deteriorated insulation at the electrical service drop wires.

- ELECTRICAL ACTION ITEMS:**
1. Some of the wire insulation at the main service drop conductor splices was deteriorated (visible from the roof). This insulation should be repaired or replaced to prevent direct contact with the conductors.

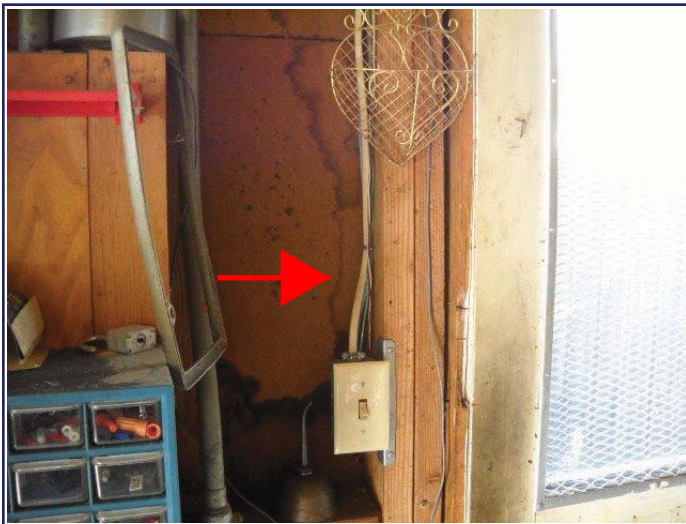
Photo 11

Unprotected wiring below 7ft in the garage.

3. There was unprotected wiring under 7ft in the garage. This wiring should be protected in conduit or behind an appropriate wall covering.
 4. There was an uncovered junction box in the cabinet under the cooktop. A cover should be installed to protect the wiring from damage or accidental contact.

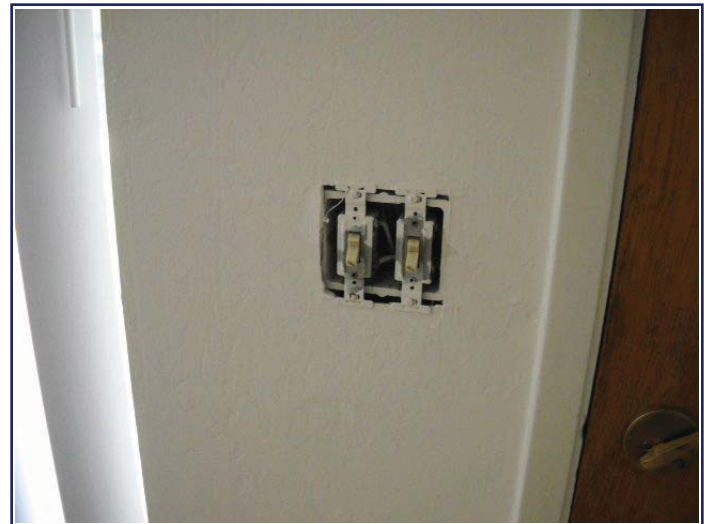
Photo 12

Missing switch cover plate in the living room.

6. The light switches adjacent to the front door were missing their cover plate, which should be replaced to help prevent accidental contact with the wiring.

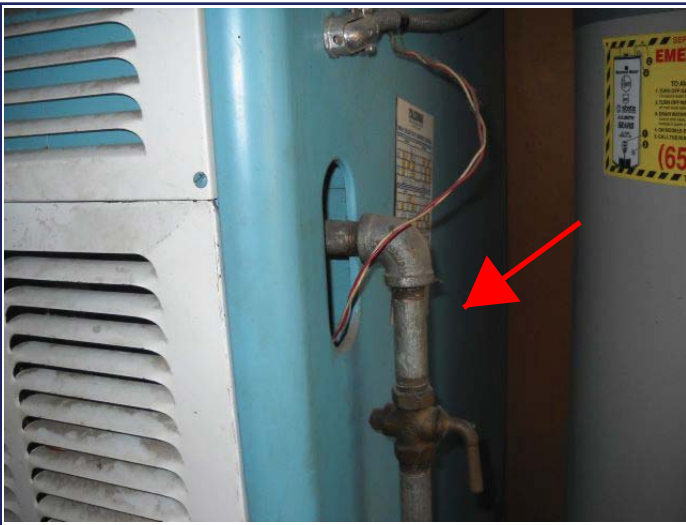
Photo 13

No flexible connector at the furnace gas supply line.

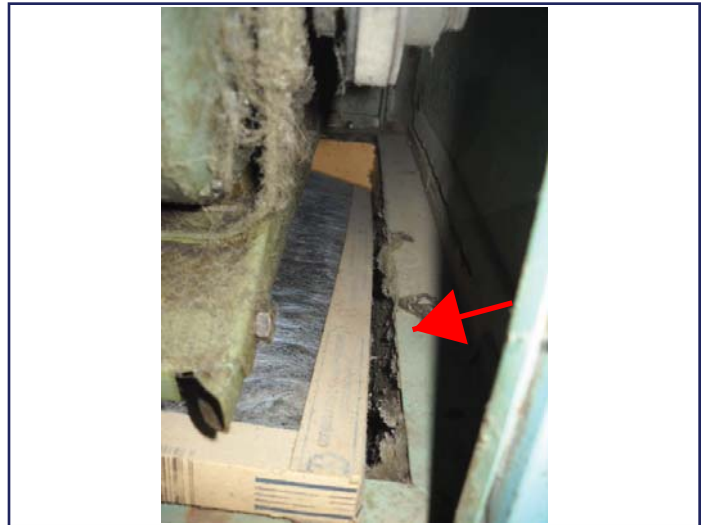
Photo 14

Undersized return air filter inside the furnace.

1. The furnace was an older unit and may be nearing the end of its useful life. Additionally, it did not respond when tested with the thermostat (the pilot lights were lit), the return air filter was undersized, the blower compartment was excessively dirty and there was no flexible gas connector installed. The homeowner should anticipate the need to replace the furnace, possibly in the near future. Please note that even if an older furnace operates normally during the inspection, a detailed examination of the unit by a qualified HVAC contractor might reveal potential problems that are not readily visible (such as a cracked heat exchanger).

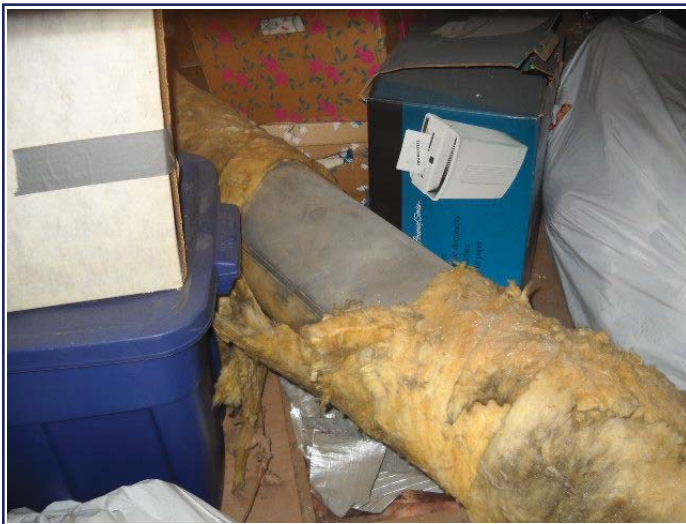
Photo 15

Torn and missing duct insulation in the attic.

3. There was some discoloration on the ductwork insulation in the garage, which may indicate leaking duct joints. Additionally, there was some torn and missing insulation on the ducts in the attic. Properly sealing the joints and insulating the ducts will help improve the efficiency of the heating system.

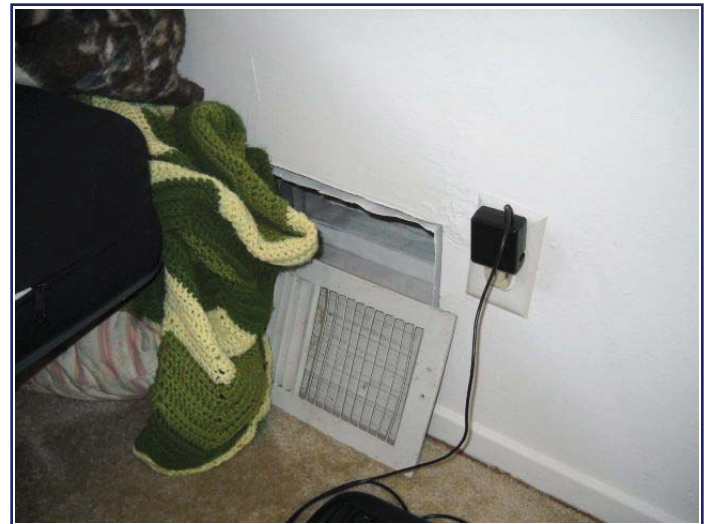
Photo 16

Loose heat register cover in the front bedroom.

4. The loose heat registers in the bedrooms should be re-secured.

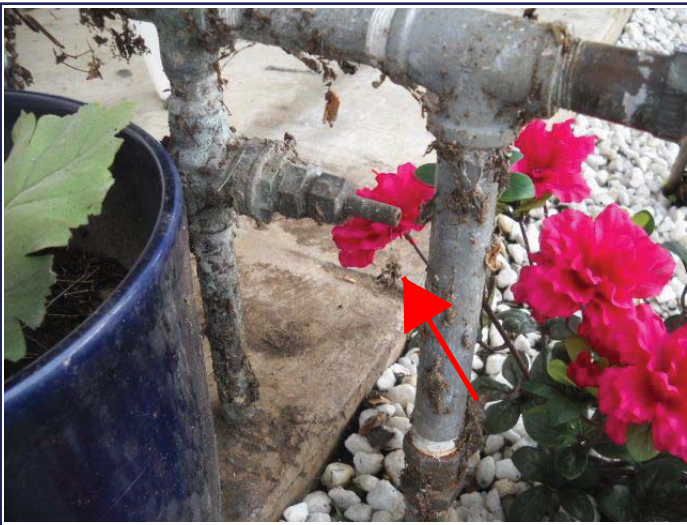
Photo 17

Missing handle at the main water shutoff valve.

1. The main water shutoff valve was missing and should be replaced so the water can be turned off quickly for maintenance or in an emergency.
2. The water heater vent connector was separated from the draft diverter. This should be corrected to prevent combustion gases from leaking into the garage.
3. There was corrosion and some leaking around the hot water connection at the top of the water heater. This connection should be replaced to prevent ongoing corrosion, leaking and possible damage.
4. The water heater temperature & pressure relief valve drain line was terminated in the drip pan above the raised platform, which is incorrect. The drain line should terminate 2-6" from the garage floor, or be routed to the exterior of the house.

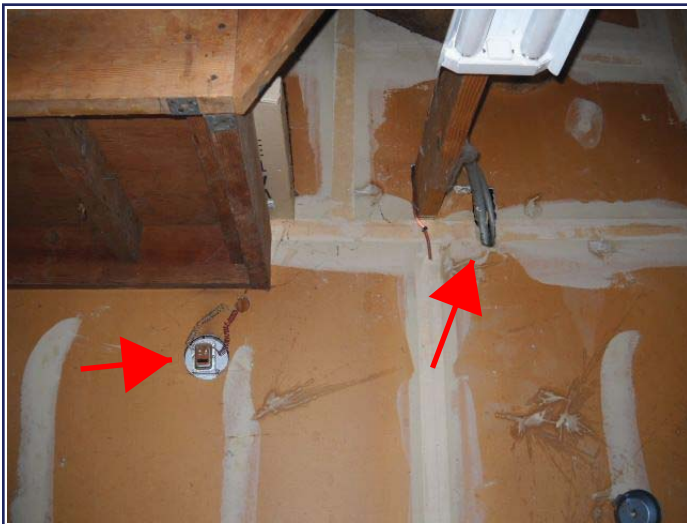
Photo 19

Some of the unsealed firewall penetrations at the right side of the garage.

1. There were a few unsealed firewall penetrations around the conduit and electrical boxes at the right side of the garage. These areas should be properly sealed by a qualified contractor to restore the integrity of the firewall. The heat register in the garage should be removed, and the opening in the furnace plenum sealed. Additionally, the attic access in the garage was completely open. A fire-rated access door should be installed.
2. There was a pet-flap breach in the interior door to the garage. This modified door should be replaced with a fire-rated door to help maintain an effective fire barrier between the garage and the living portion of the house.
3. The bedroom hallway smoke alarm appeared to be old unit, and I recommend it be replaced. As an upgrade for safety, I also recommend installing smoke alarms in each bedroom.

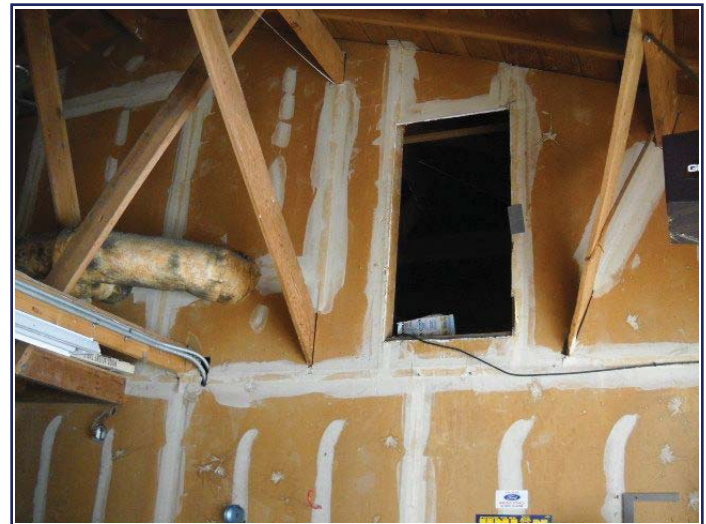
Photo 20

Open access to the attic.
